# JOINT TRANSPORTATION RESEARCH PROGRAM

## EVALUATION OF EFFECTS OF SUPER-HEAVY LOADING ON THE US-41 BRIDGE OVER THE WHITE RIVER

Report Number: FHWA/IN/JTRP-2011/15

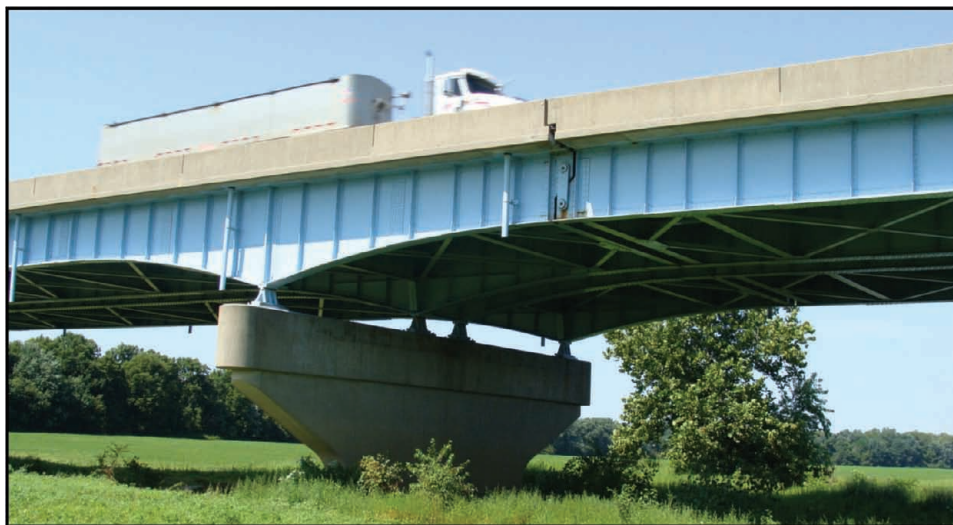
Figure 4.31: Photograph of pin and hanger

It can be seen in the plot that a very minimal response was measured at CH\_33 during the controlled test. The peak stress was only 0.6 ksi. This occurred as the trucks crossed over the hanger onto the 'hung' span. Figure 4.31 is a photograph of the pin and hanger illustrating this concept. As can be seen in the photo, the traffic in the northbound lane crosses over Pier 13, onto the cantilevered span, and then onto the hanging span. Once the test trucks are on the suspended span, the

hanger goes into tension to support the hanging span. It should be noted that the photograph in Figure 4.31 was taken prior to the installation of instrumentation on the US-41 White River Bridge; therefore, no strain gages are present in the photograph.

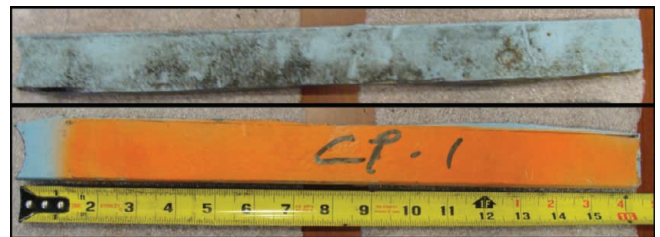
Figure 6.1: Example material sample

Steel samples were removed from the US-41 White River Bridge to perform material testing. The samples were extracted from a main girder angle and cover plate as well as the flange angle of a transverse floor beam. Upon receiving the floor beam specimen, a significant amount of pitting due to corrosion was noted. The samples were sent to be machined and tested. During this process, the floor beam sample was found to be too pitted with corrosion to manufacture a valid Charpy V-Notch (CVN) test specimen; thus, an additional floor beam sample was removed during the controlled load testing on November 24, 2009. A photograph of an example material sample removed from the cover plate can be seen in Figure 6.1.

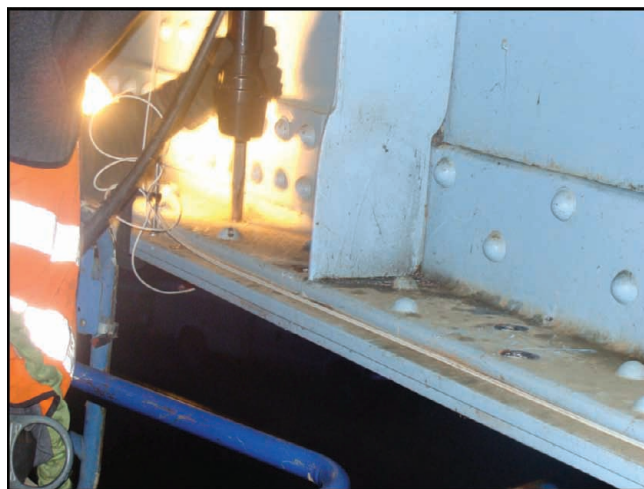
Figure 6.9: Driving the rivet out

A total of 214 rivets were removed from several spans in the northern half of the northbound and southbound bridge superstructures (exact locations of all rivets removed can be found in the rivet removal plan attached to this report in Appendix B). The rivets were removed by shearing off the top rivet head and then driving the rivet out of the hole with a pneumatic chisel. All 214 rivet holes were inspected both visually and with magnetic particle testing. No cracks or defects were found in any of the 214 inspected holes. Once the inspection was complete and the condition documented the rivet was replaced with a fully pretensioned high-strength bolt. If the area around the rivet hole or the rivet hole itself was damaged at all during the removal process it was properly ground smooth as to not negatively impact the fatigue performance of the member. Lastly, all the new bolts were painted to reduce the potential for corrosion. All rivet removal and inspection work was performed by Wiss, Janney and Elstner, Inc. (WJE) from Northbrook, IL between December 14 and 16, 2009. Photographs taken during the rivet removal and inspection work can be seen in Figure 6.8 through Figure 6.10. (It should be noted

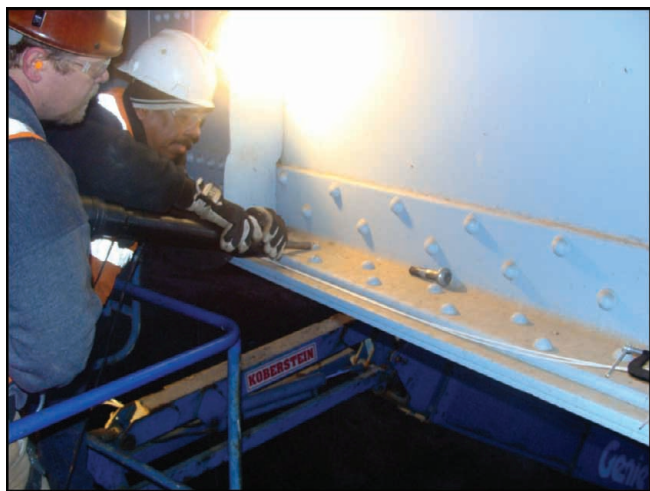
Figure 6.8: Shearing off the rivet head

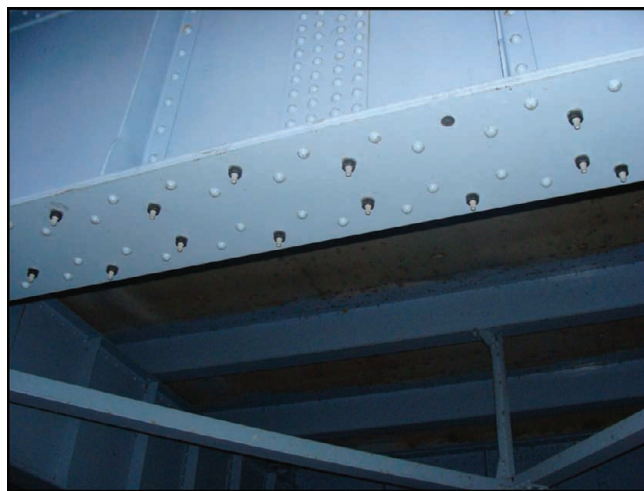
Figure 6.10: Example rivet hole sample location

that Figure 6.10 is only used to illustrate an example sample location of rivet holes and is not the final condition of the pretensioned bolts.)

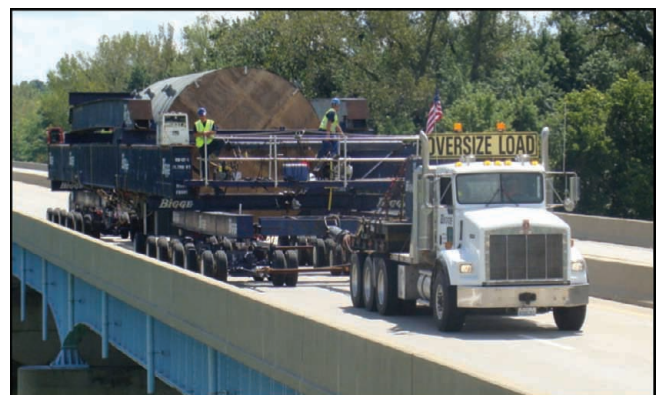
Figure 7.1: Photograph of beam and dolly transporter from the front

All superloads were transported by Bigge Crane and Rigging Company headquartered in San Leandro, CA. The most common superload vehicle configuration used was the beam and dolly transporter. Other superload vehicle configurations were used as well; however, the heaviest of the loads were moved by the beam and dolly transporter. The beam and dolly transporter uses large steel beams to carry the weight of the payload out to two supporting dollies. These dollies consist of multiple axles having four tires. Hauling the load in this fashion spreads the weight out over a large area, thereby reducing the impact on any single concentrated area. Example photographs of a beam and dolly transporter can be found in Figure 7.1 and Figure 7.2. As seen in the photographs two trucks or ‘prime movers’ were often required to transport the super-heavy loads. It should also be noted that the weight of the moving equipment alone (i.e., prime movers and beam and dolly transporter) was by no means negligible and substantially contributed to the gross weight of the superloads.

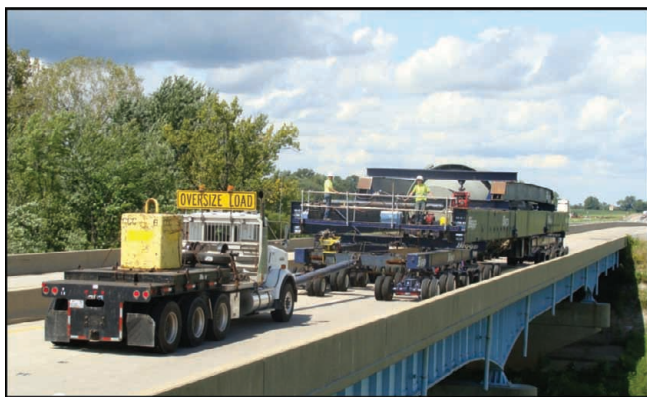
Figure 7.2: Photograph of beam and dollie transporter from the rear

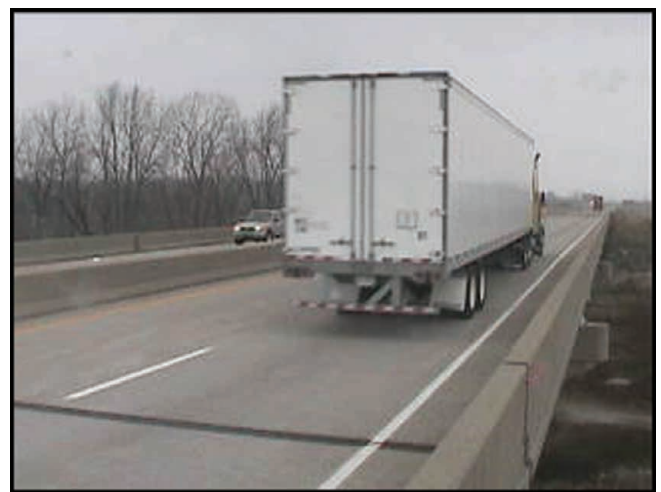
Figure 8.1: Single truck trigger video image

It was not uncommon for a standard tractor-trailer semi to trigger data collection. Figure 8.1 is a photograph taken by the video camera during a single tractor-trailer semi trigger event. As mentioned above, the trigger stress value was set such that only heavily loaded vehicles would cause a trigger event. Thus, it is likely that the tractor-trailer pictured was fully loaded. The selected trigger event pictures a semi having a standard box trailer; however, other types of single standard tractor-trailer vehicles also commonly triggered data collection. These other standard vehicles commonly triggering the daily traffic trigger included grain trucks, logging trucks, and gravel trucks.

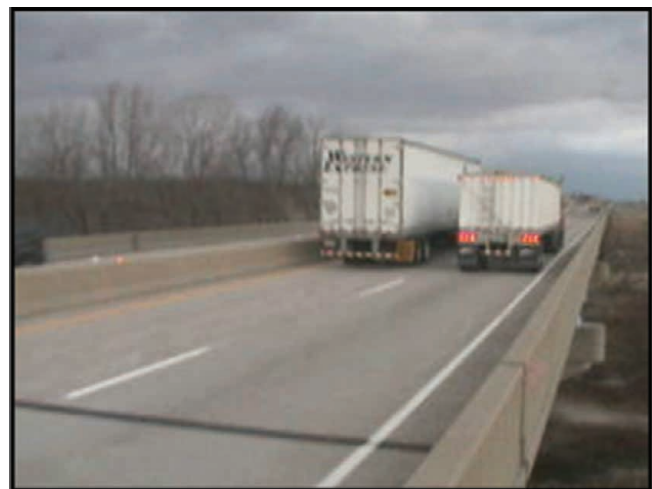
Figure 8.3: Double truck\_1 trigger video image

A more commonly occurring trigger was due to a double truck event. Figure 8.3 shows a video image captured by the video camera mounted on the US-41 White River Bridge during the double truck\_1 event. Typically the double truck events consisted of two standard tractor-trailer semi trucks; however, other combinations were also observed to trigger data collection. The plot for the double truck\_1 event is shown in Figure 8.4. As expected, the double truck\_1 event results in greater stresses than the single standard tractor-trailer. The trigger channel, CH\_24 (pink trace), had a maximum stress of approximately 2.8 ksi. CH\_4 again had the greatest stress range; however, for the double truck\_1 event it increased to 6.8 ksi. Another notable feature of the plot is the load distribution. It would be expected that CH\_24 and CH\_26 would have identical stresses if both lanes are loaded; however, this is not the case in Figure 8.4. CH\_24 has a greater

maximum stress by approximately 0.5 ksi. This is likely because the truck in the right lane is heavier. Looking at the photograph, the right truck is a grain truck which was commonly found to trigger data collection themselves. Thus, the most likely reason for the difference in peak stress is the varying weights of the two trucks.

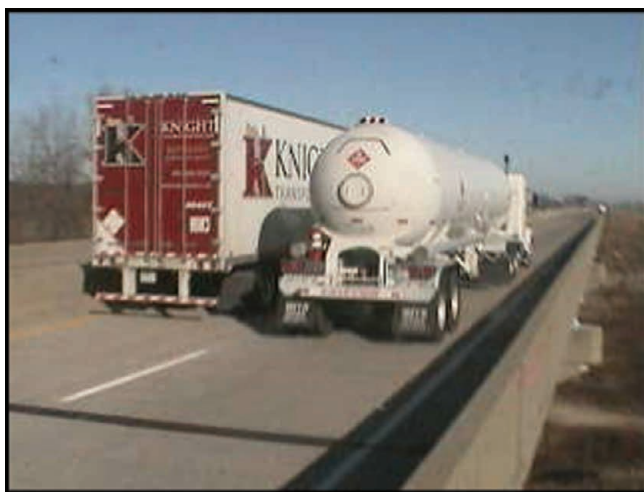
Figure 8.5: Double truck\_2 trigger video image

A second double truck event was also included for comparison. Figure 8.5 is a photograph of the double truck\_2 trigger event. This event features a standard tractor-trailer box truck in the left lane and a standard tractor-trailer tanker truck in the right lane. The maximum stress for CH\_24 during this event was

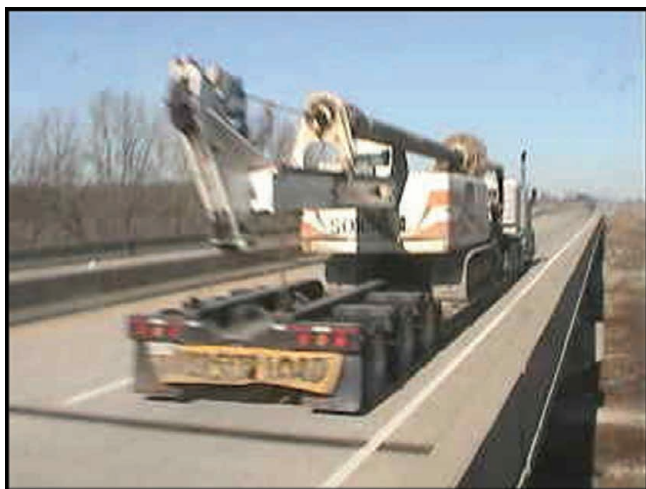
Figure 8.7: Drill rig trigger video image

Beyond standard vehicles, other non-standard vehicles triggered data collection. One such vehicle was the drill unit pictured in Figure 8.7. The drill unit produced stresses greater than a standard tractor-trailer trigger event but less than the double truck trigger events. A plot of the data measured during the drill rig trigger event is shown in Figure 8.8. As can be seen the maximum stress at the trigger channel, CH\_24 (pink trace), was approximately 2.3 ksi. As expected, this was between the stress produced during a standard single and double trigger event. Likewise, the maximum stress

range was also between the two standard events, CH\_4 measured a maximum stress range of 5.9 ksi. The load distribution for the drill rig trigger event was similar to the single truck event. Since the drill rig was driving in the right lane, CH\_24 measured a greater stress than CH\_26.
